eco-structure

BY TOM HUTCHINSON, AIA, FRCI, RRC

CHALLENGING WHAT'S COOL

IS THE EXPONENTIAL GROWTH OF COOL ROOFING AN IMPENDING CATASTROPHE?

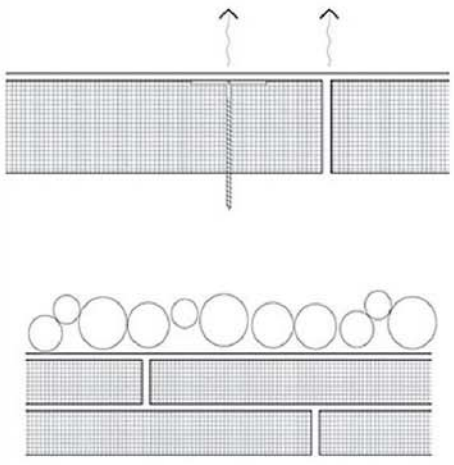
Single-layer mechanically fastened roof systems are up to 15 percent less energy efficient than double layer systems with offset joints.
