## Waste not

### An EPDM recycling initiative explores the environmental potential of EPDM

by Thomas W. Hutchinson, AIA, RRC, FRCI

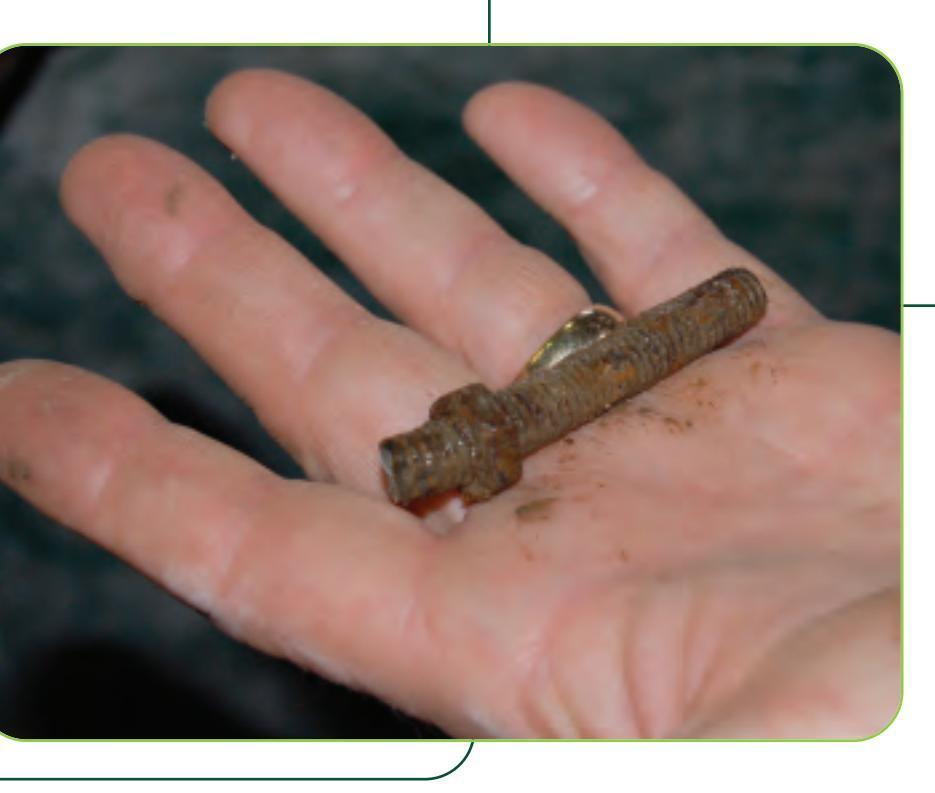
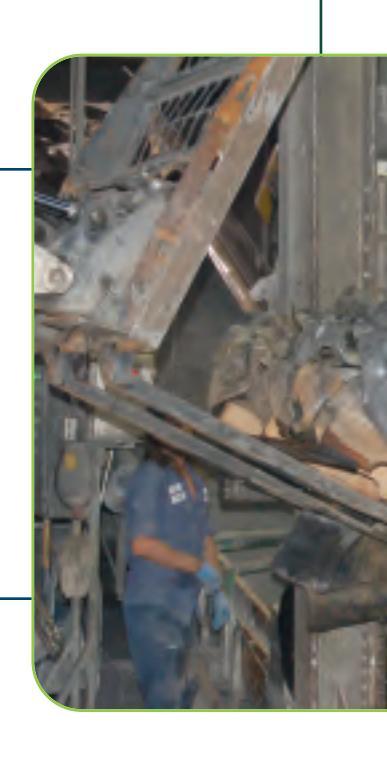
On Aug. 29, 2006, the task force and MEI representatives observed the grinding of the pilot project's EPDM material. The material was lifted by forklift and placed into a container box. At the end of the container box there was a hydraulic ram that pushed the roofing material toward the open end of the container box where a large hydraulically driven steel plate sliced the membrane into smaller sections so it could be pulled apart and inspected by MEI employees, who searched for contaminants. Employees removed the contaminants, including screws, plates, sealants and insulation pieces, by hand.

The sliced sections of EPDM membrane then passed under a metal detector for additional contamination inspection and moved onto a sloped conveyor belt,

which transferred the material to the granulator. The granulator had 18 rotating fly knife blades that reduced the membrane to about <sup>3</sup>/<sub>6</sub>-inch-wide and -long material pieces. As the ground material was moved by conveyer toward container boxes of about 1,600 to 1,700 pounds per box, talc was added to prevent agglomeration. This first grind was called a "work in progress."
